GEO-ENVIRONMENTAL ASSESSMENT
LYDDEN
DOVER
QUINN ESTATES LTD
GEA-21929A-19-451
OCTOBER 2019

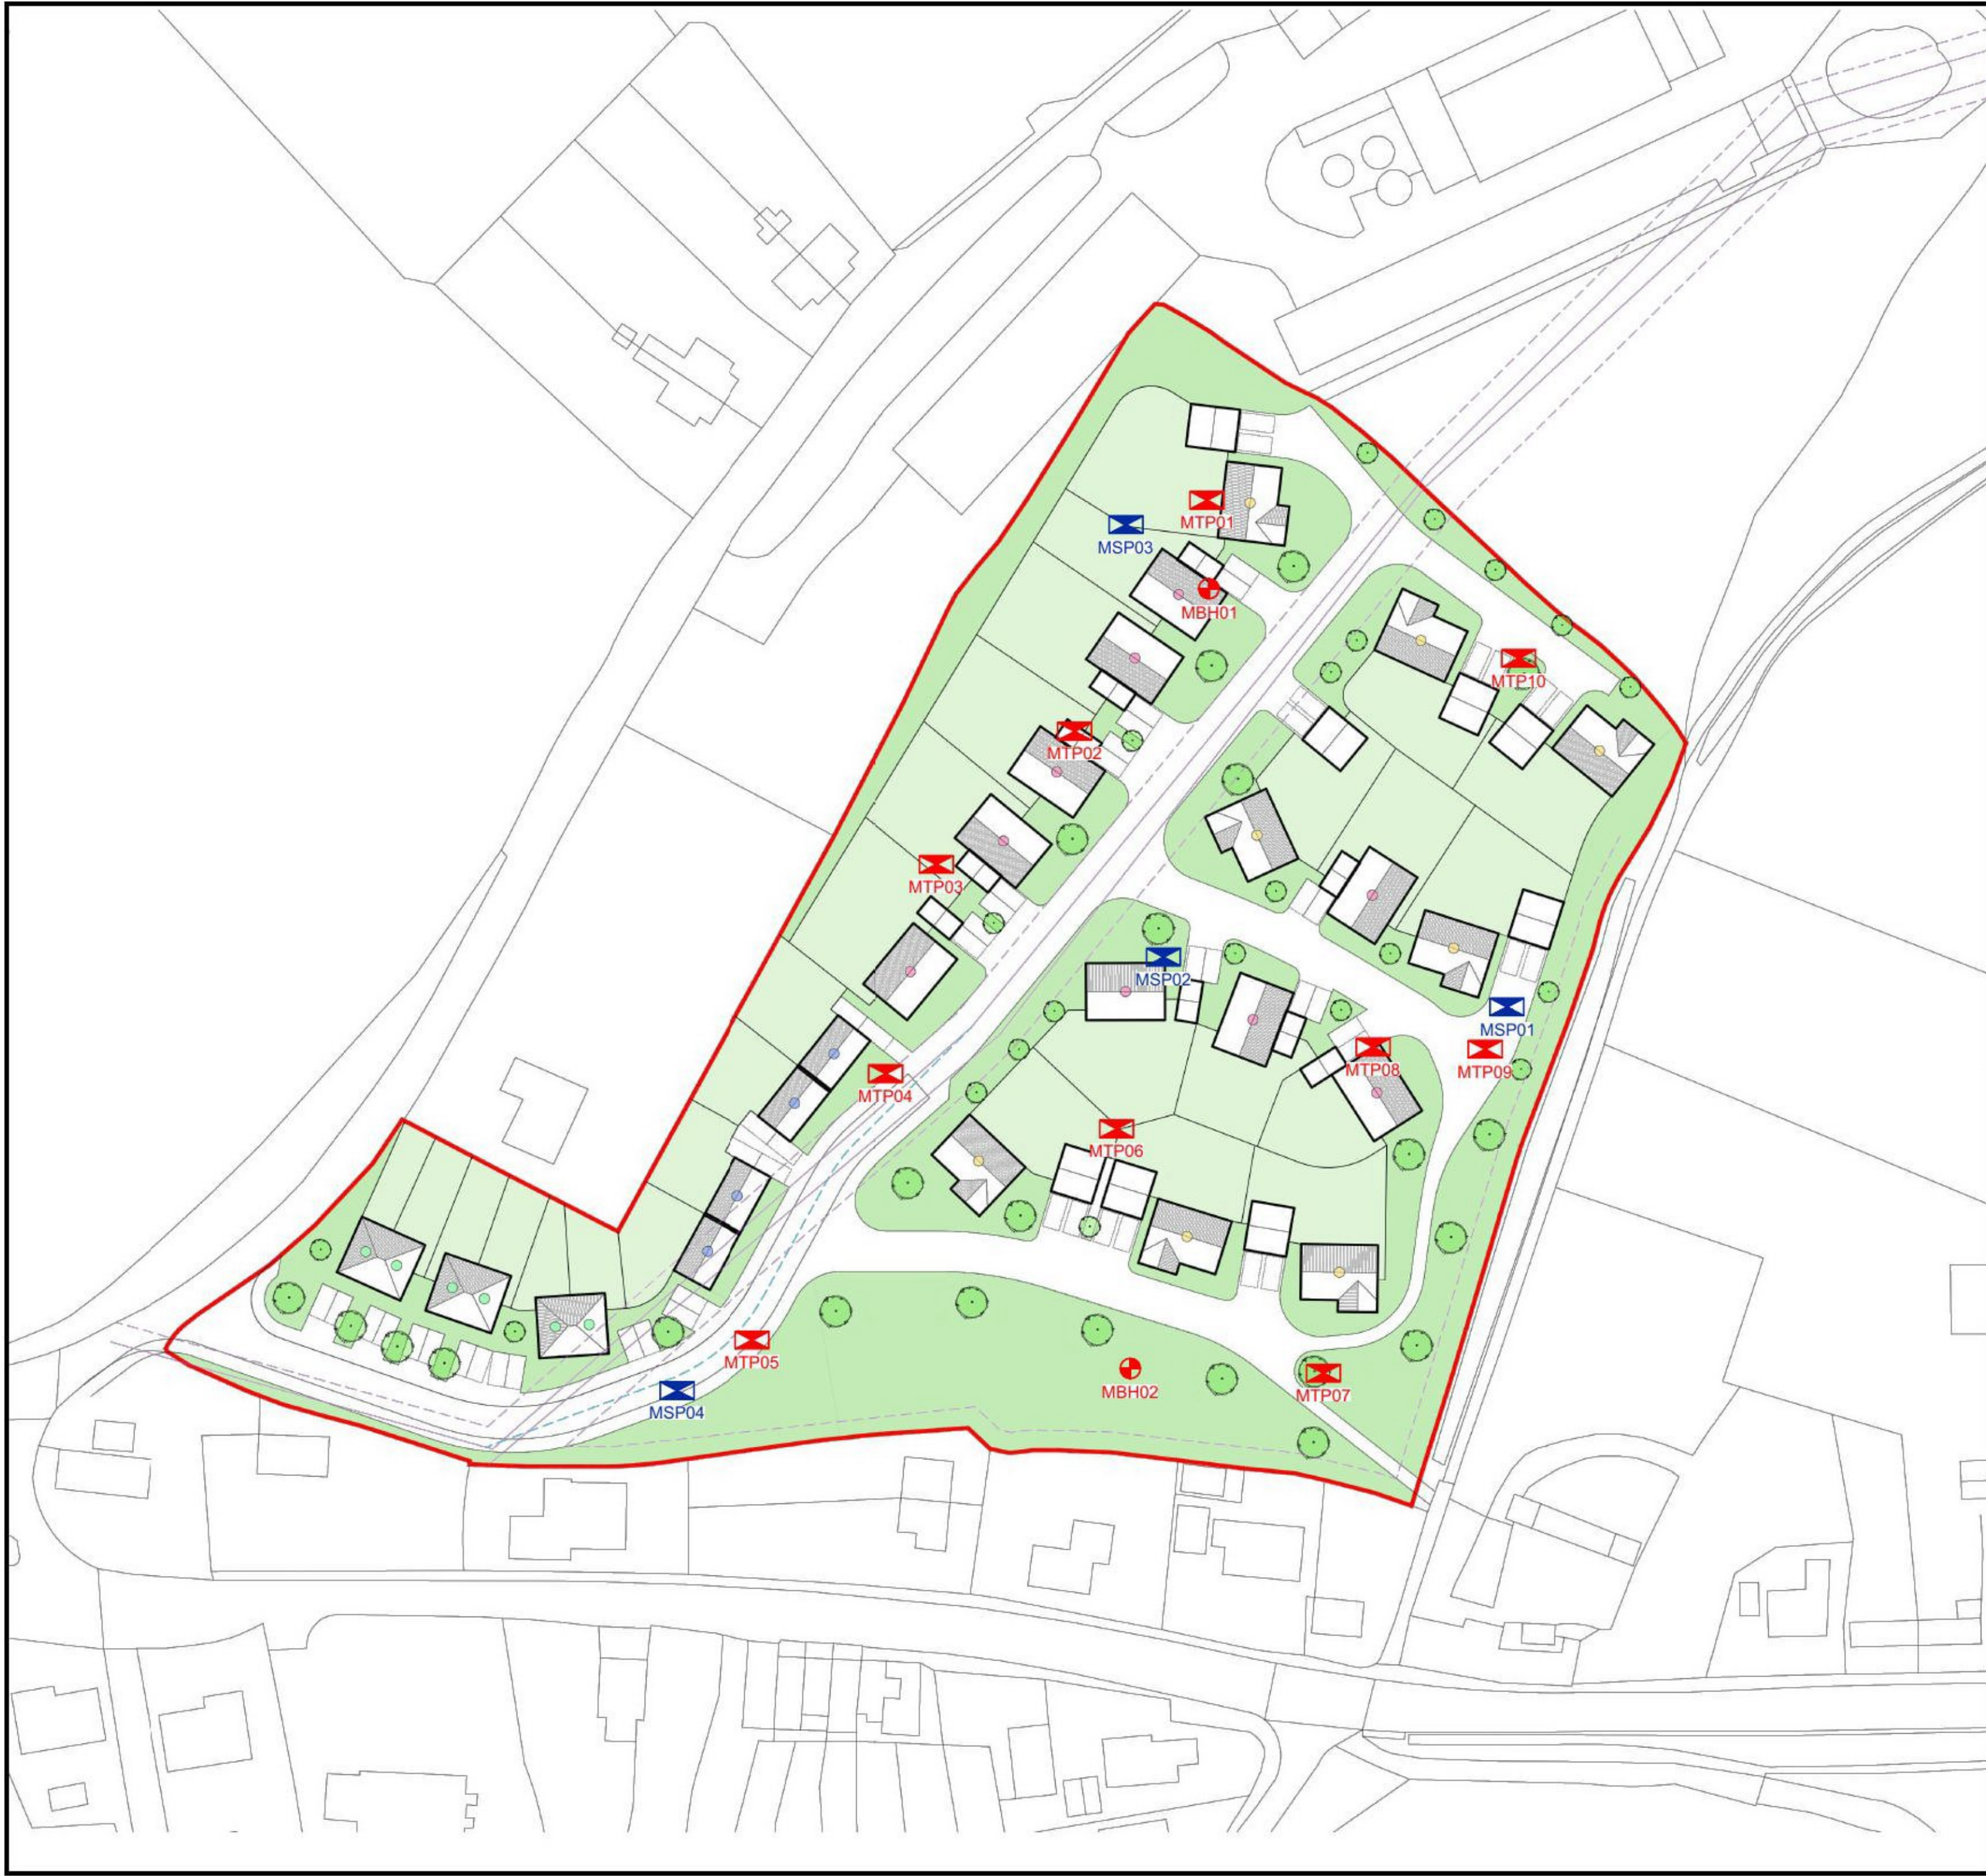
Legend

- Site boundary
- MBHref Merebrook borehole with location reference
- MTPref Merebrook trial pit with location reference
- MSPref Merebrook soakage test with location reference

- 3.2.4 The two boreholes were installed with slotted pipe within gravel to form a response zone in the underlying natural ground and plain pipe topped by bentonite was used to form a seal. MBH01 was installed to 5 m bgl with 3 m of plain pipe followed by 2 m of slotted pipe. MBH02 was installed to 15 m with 5 m of plain pipe followed by 10 m of slotted pipe. The installations were subsequently used to detect groundwater and monitor the natural ground gas conditions.
